JANICE K. BREWER
Governor

HERBERT R. GUENTHER
Director

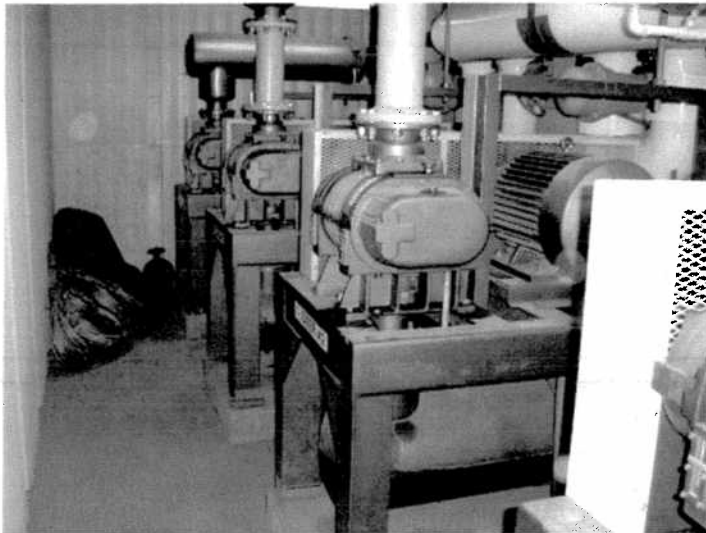
PHOTO NUMBER: 1
PHOTO DIRECTION: North
DESCRIPTION: Blowers #1-3 located inside of the control room above the right abutment of the downstream dam.

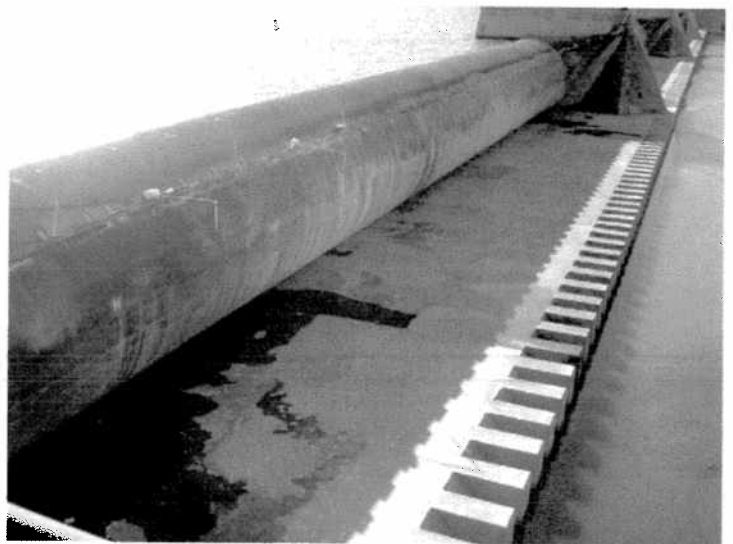
PHOTO NUMBER: 6
PHOTO DIRECTION: Southeast
DESCRIPTION: Close-up view of bladder #4 as seen from above. The white paint spots represent a recent crack survey.

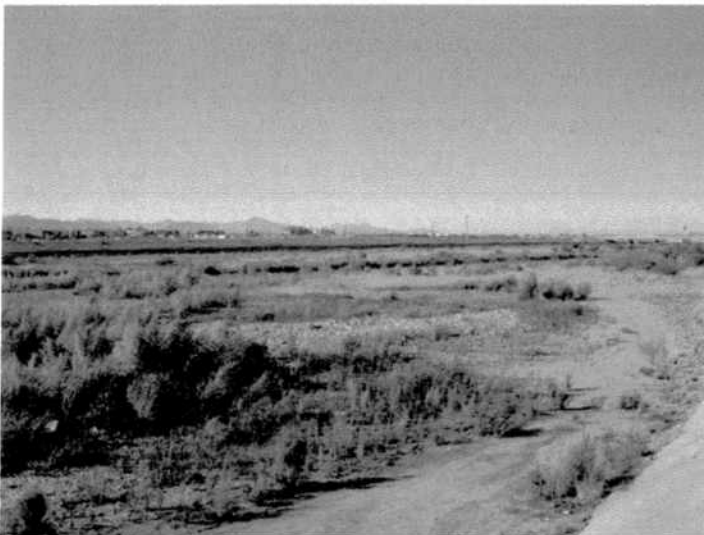
PHOTO NUMBER: 7
PHOTO DIRECTION: West
DESCRIPTION: Toward downstream as seen from above the right abutment or north side of the river bank.

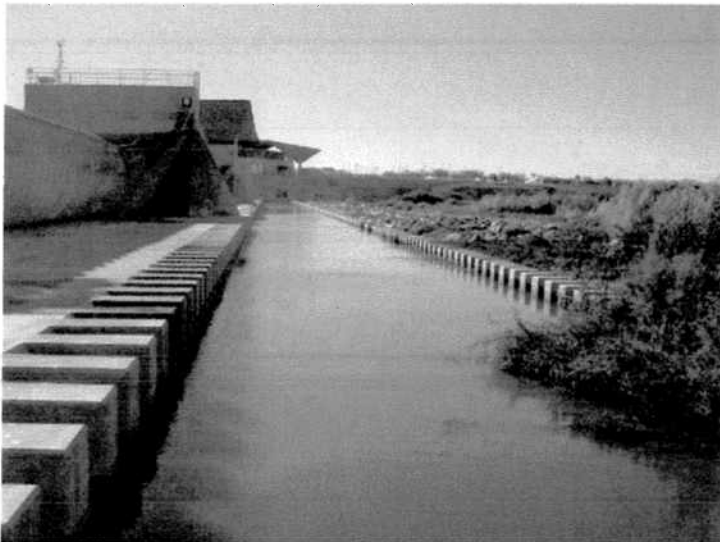
PHOTO NUMBER: 9
PHOTO DIRECTION: South
DESCRIPTION: Another view along the stilling basin and foundation slab from the right abutment.

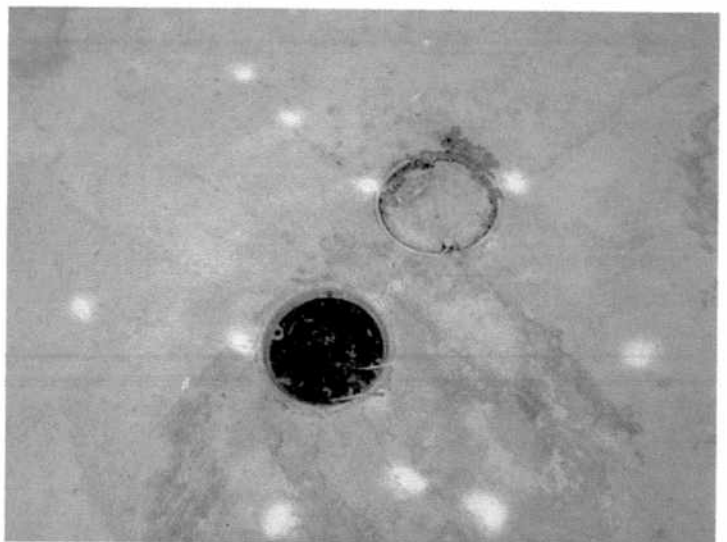
PHOTO NUMBER: 10
PHOTO DIRECTION: Down
DESCRIPTION: One of the piezometers located in the foundation slab below bladder #4.

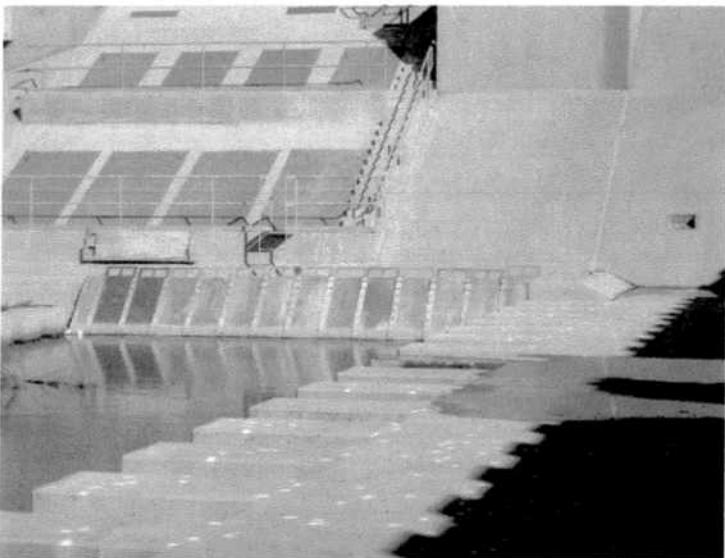
PHOTO NUMBER: 11
PHOTO DIRECTION: North
DESCRIPTION: Screens (trash racks) located over the inlet structure of the downstream dam at the right abutment.

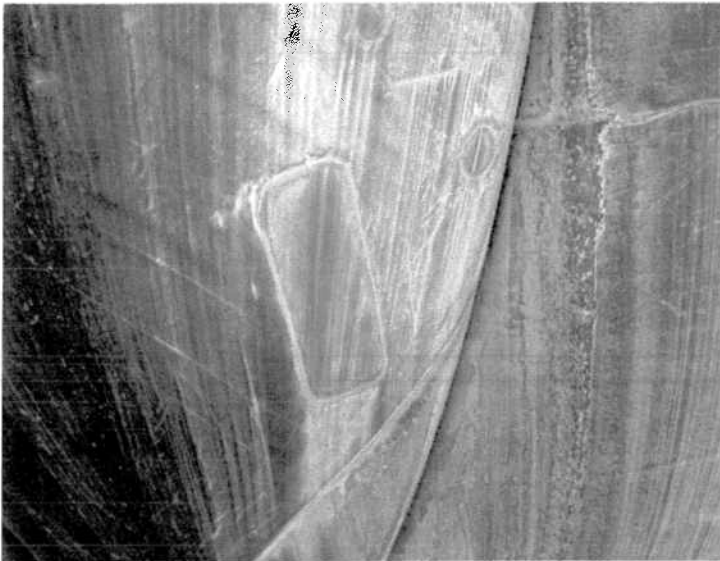
PHOTO NUMBER: 13
PHOTO DIRECTION: East
DESCRIPTION: Close-up view of one of the repair patches; this one located on bladder #4.

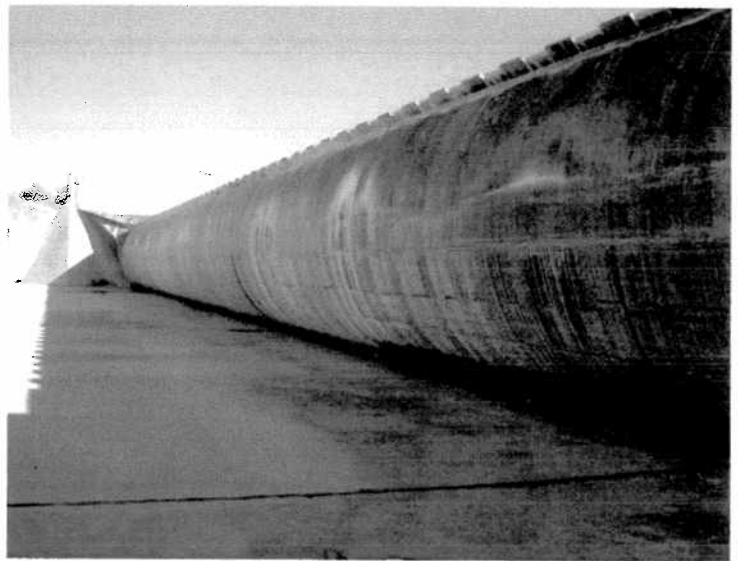
PHOTO NUMBER: 14
PHOTO DIRECTION: North
DESCRIPTION: Along the downstream side of bladder #3.

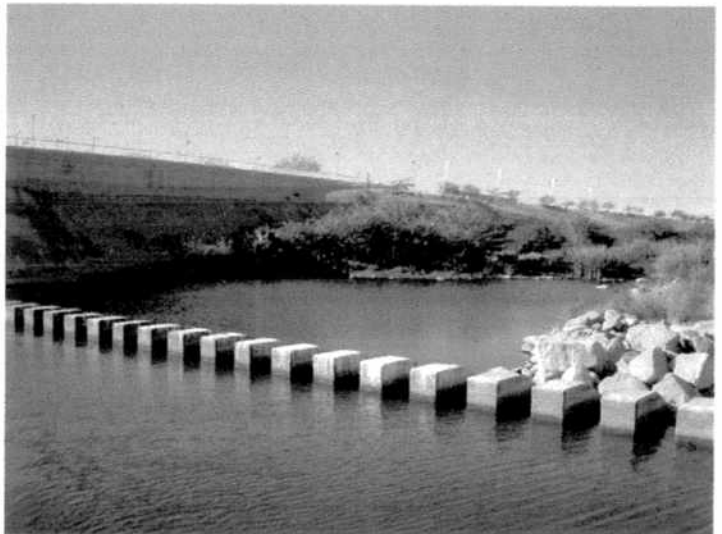
PHOTO NUMBER: 16
PHOTO DIRECTION: West
DESCRIPTION: Toward downstream below bladder #1 and the area of missing riprap. There are plans to replace the riprap in the near future.

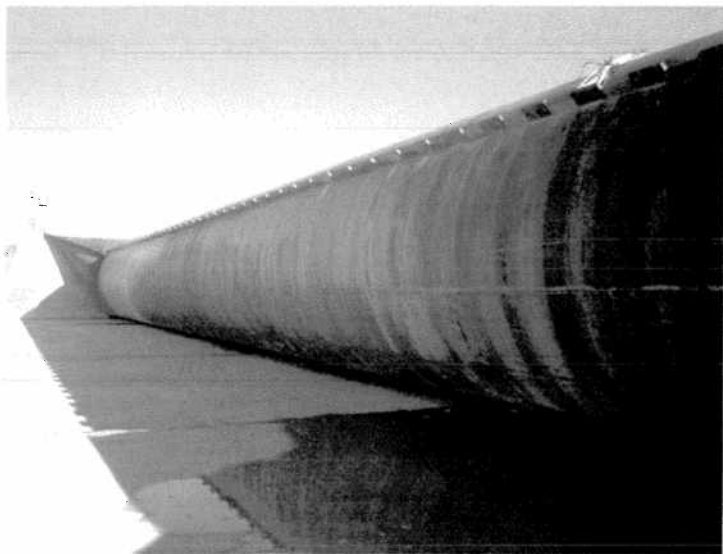
PHOTO NUMBER: 17
PHOTO DIRECTION: North
DESCRIPTION: Along the downstream side of bladder #1. Bladder #1 is slightly lower than the other three and thus acts as an emergency spillway.

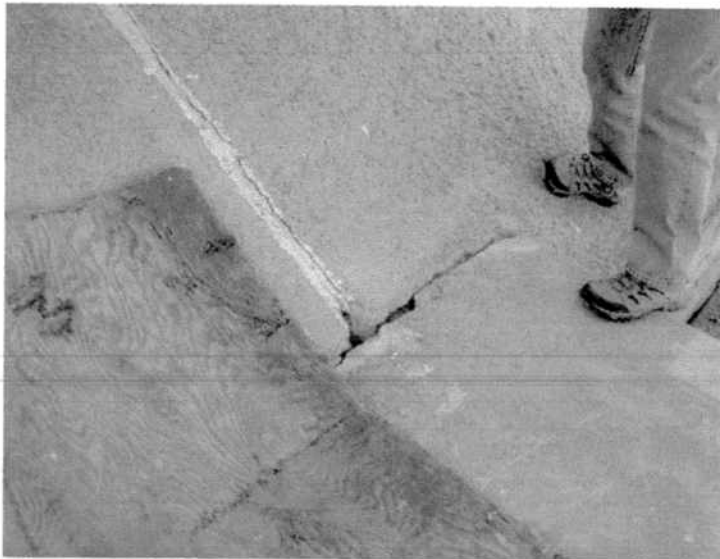
PHOTO NUMBER: 18
PHOTO DIRECTION: Down
DESCRIPTION: Close-up view of cracks at the contact between the left abutment and the concrete apron. 2.5-inches long x 1-inch wide x 1/2-inch deep: **Repair – seal.**

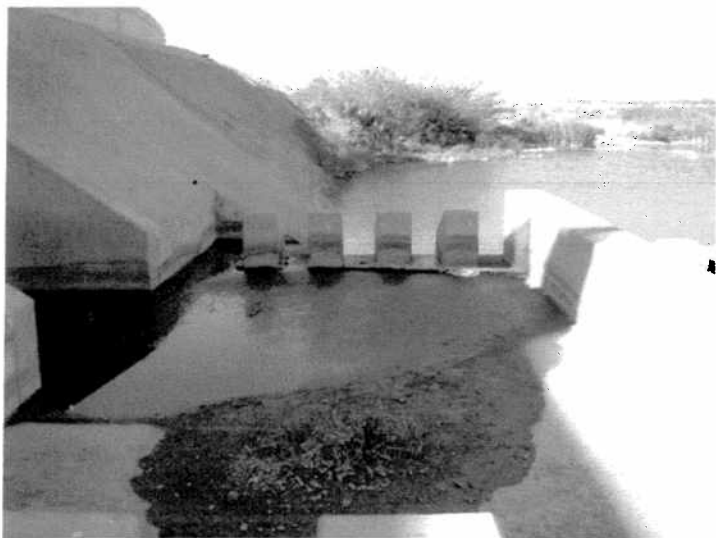
PHOTO NUMBER: 19
PHOTO DIRECTION: West
DESCRIPTION: Toward downstream as seen from the foundation slab below bladder #1.

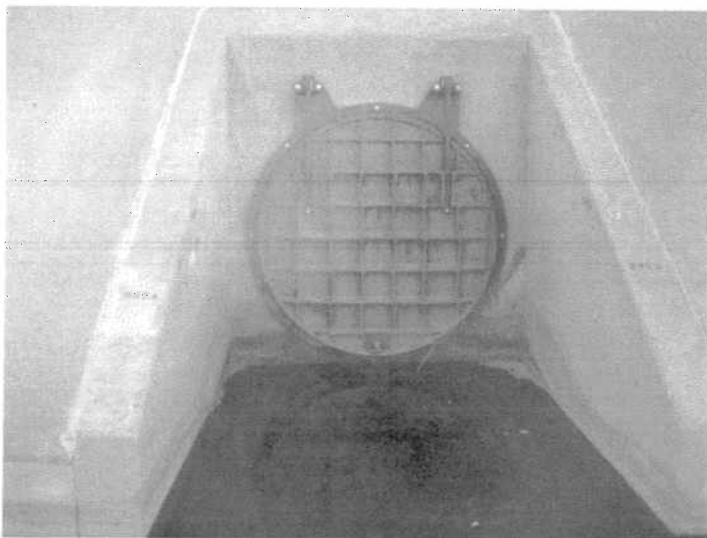
PHOTO NUMBER: 20
PHOTO DIRECTION: South
DESCRIPTION: 108-inch storm drain located under the Tempe Center for the Arts building.

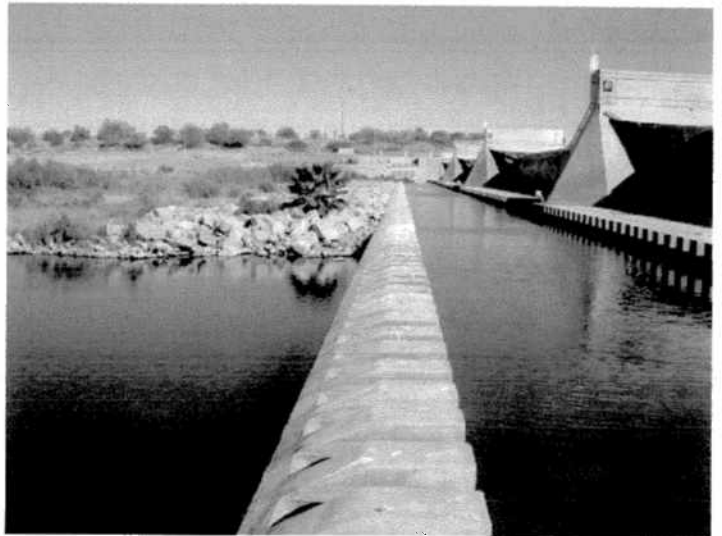
PHOTO NUMBER: 22
PHOTO DIRECTION: North
DESCRIPTION: Along the stilling basin and concrete foundation section as seen from below bladder # 1 of the downstream dam.

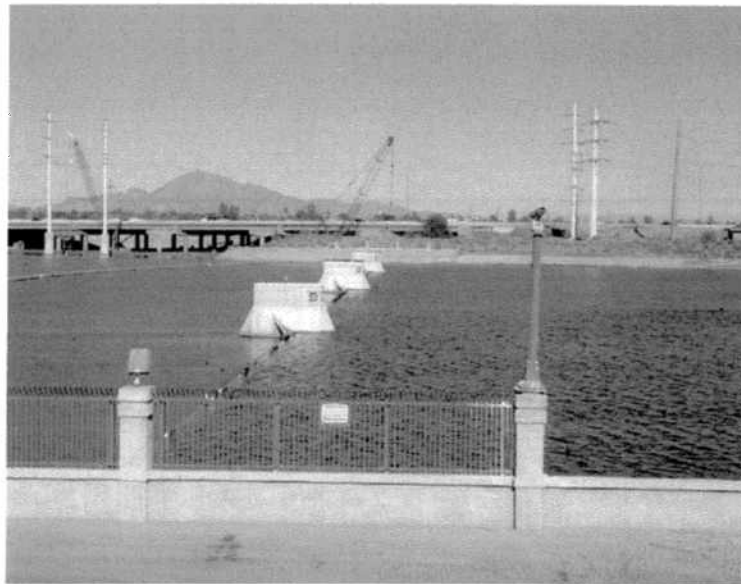
PHOTO NUMBER: 23
PHOTO DIRECTION: North
DESCRIPTION: View of the nearly submerged upstream dam as seen from the south bank.
